Manhole Inspection Summary

Manhole # S39UU_014MH

Location Address: **1001 REESE ST** Cross Street: **EXETER HALL AVE**

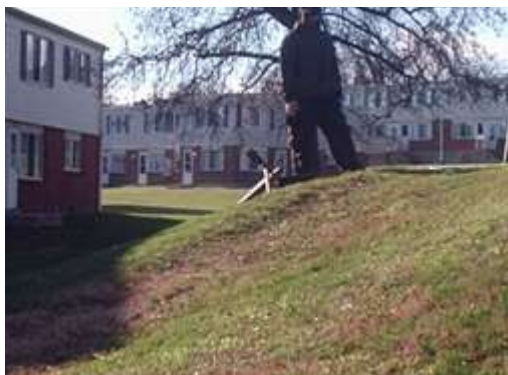
Location View

on top of hill in grass

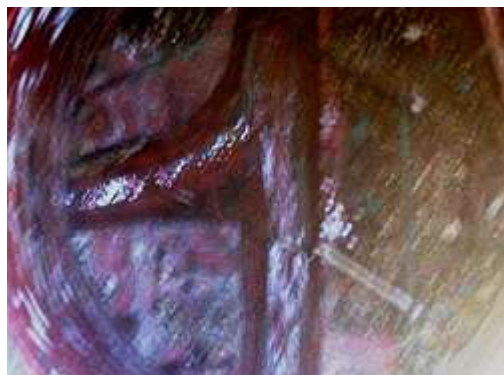
Top View

Bench debris.

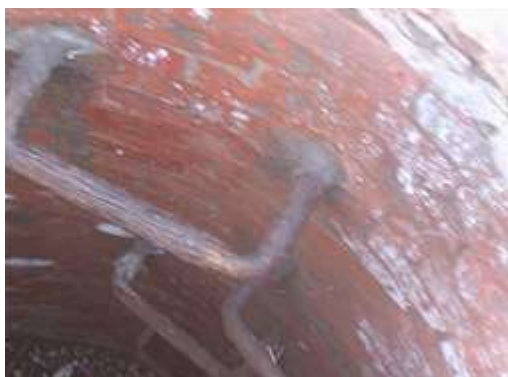
Defect

Adjustment deterioration and infiltration. Corbel and Barrel infiltration. Corroded steps.

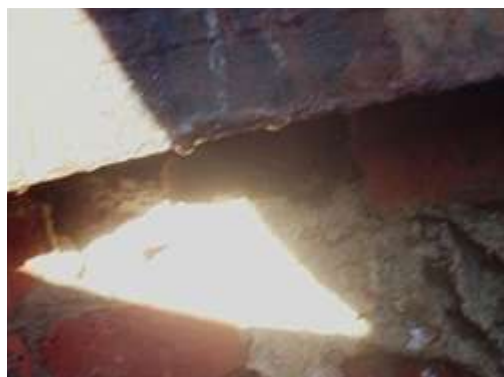
Defect

Frame leaks. Adjustment deterioration and infiltration.

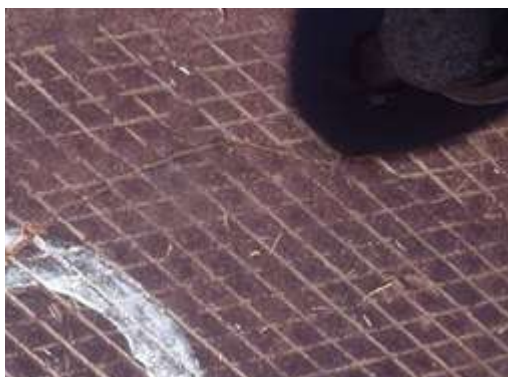
Defect

MH Cover cracks.

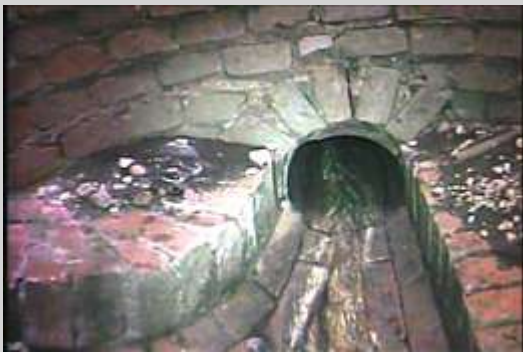
8 in. Circular Gravity Sewer Pipe Out @ 12 O'Clock

Infiltration: **Evidence** Pipe Seal Cond: **Unknown**

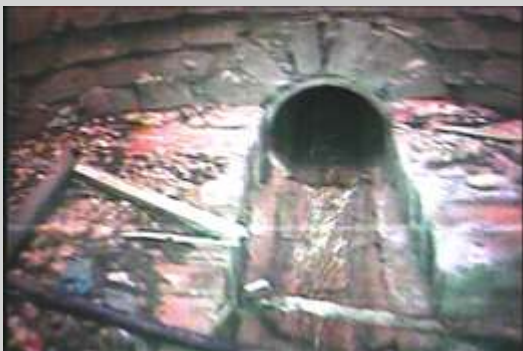
8 in. Circular Gravity Sewer Pipe In @ 6 O'Clock

Infiltration: **None** Pipe Seal Cond: **Roots**

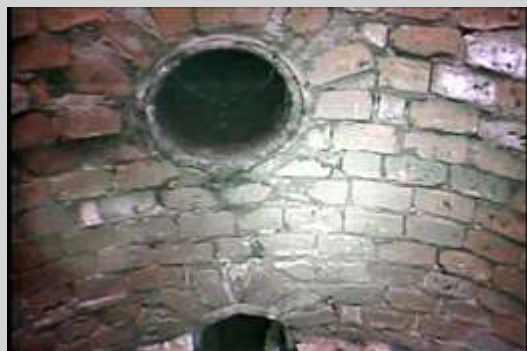
Pipe In @ 9 O'Clock

Deposits: ☐ None ☐ Mud ☐ Sludge ☐ Debris ☒ **Grease**

Infiltration: **Evidence**

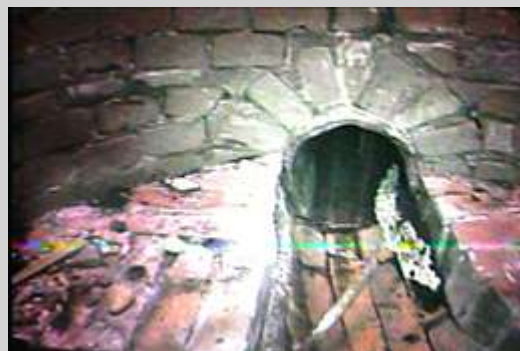
Drop In @ 9 O'Clock

Barrel deterioration and infiltration.
